D2-117017-2 REV. C

APOLLO PROGRAM

FINAL FLIGHT EVALUATION REPORT APOLLO 5 MISSION

OCTOBER, 1968

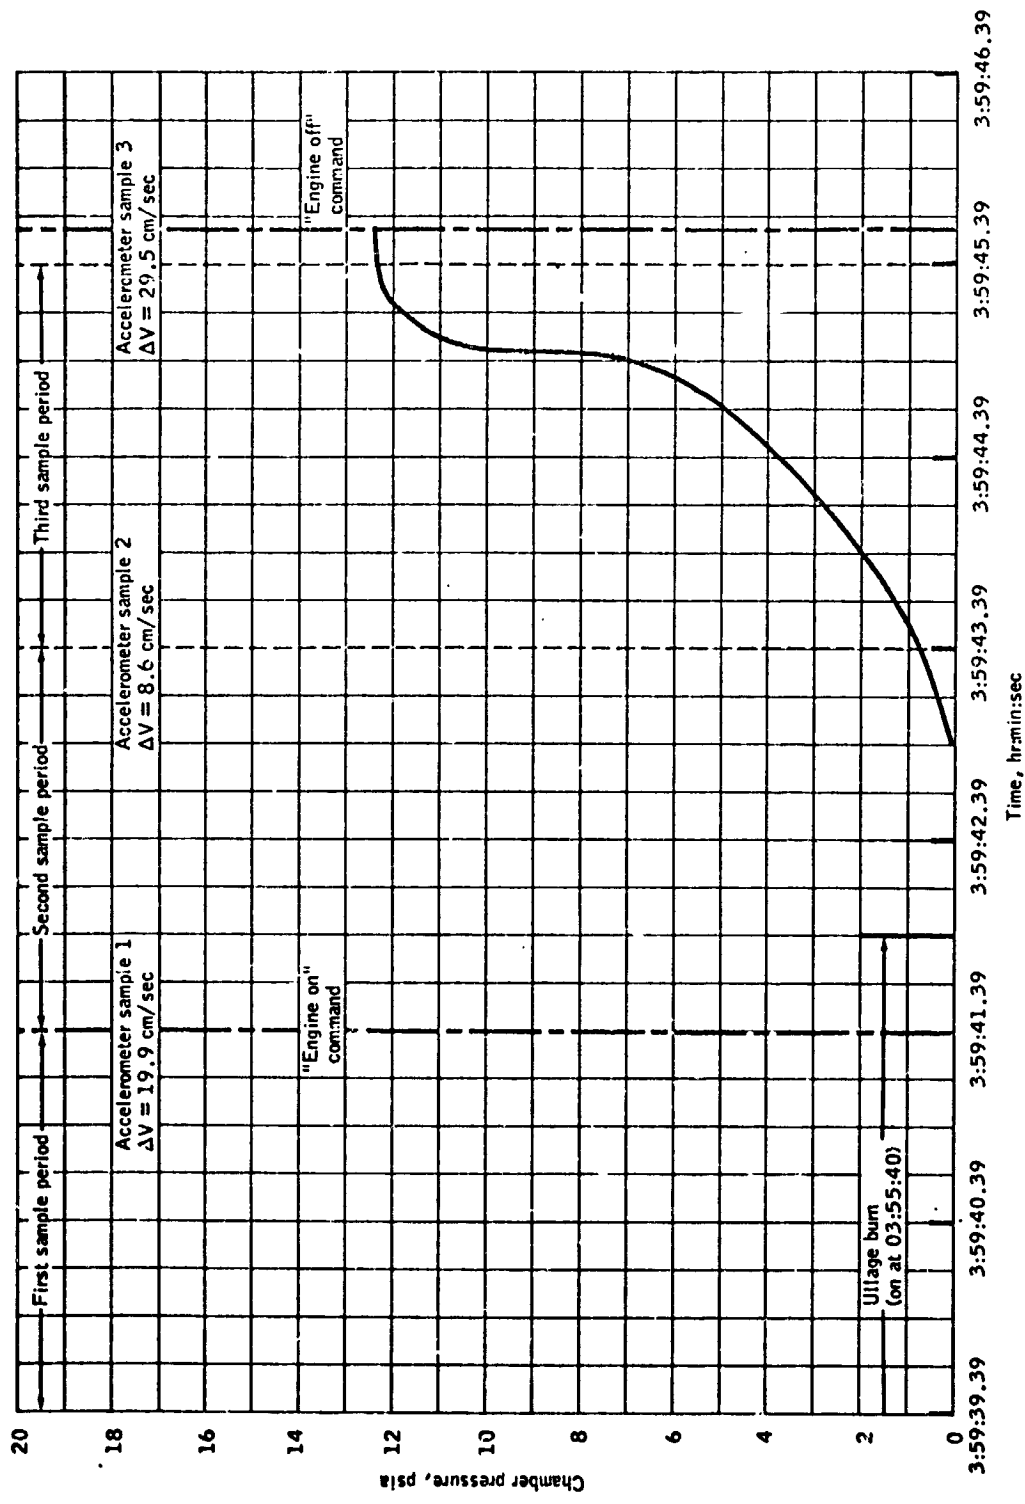
Figure 2.1-1

Because of the phasing established at Tign, minus 30 seconds, the first accelerometer sample utilized by the thrust monitor was taken within 0.01 seconds after commanded "engine on" and represented only the velocity accumulation due to the LM reaction control system (RCS) thruster ullage orientation burn. The RCS thruster burn ended 0.5 second after commanded "engine on" and therefore the second sample, taken at Tign plus 2 seconds, represented a combination of velocity accrued from the RCS thruster burn and the start of the descent engine burn. The third sample, taken at Tign plus 4 seconds, was the first that represented descent engine velocity accumulation only. Fig.2.1-1 shows the time phasing of the accelerometer samples with the descent engine chamber pressure rise. Because none of the three samples met the 45 cm/sec minimum criteria programmed in the LM guidance computer, the engine was commanded off by the computer.

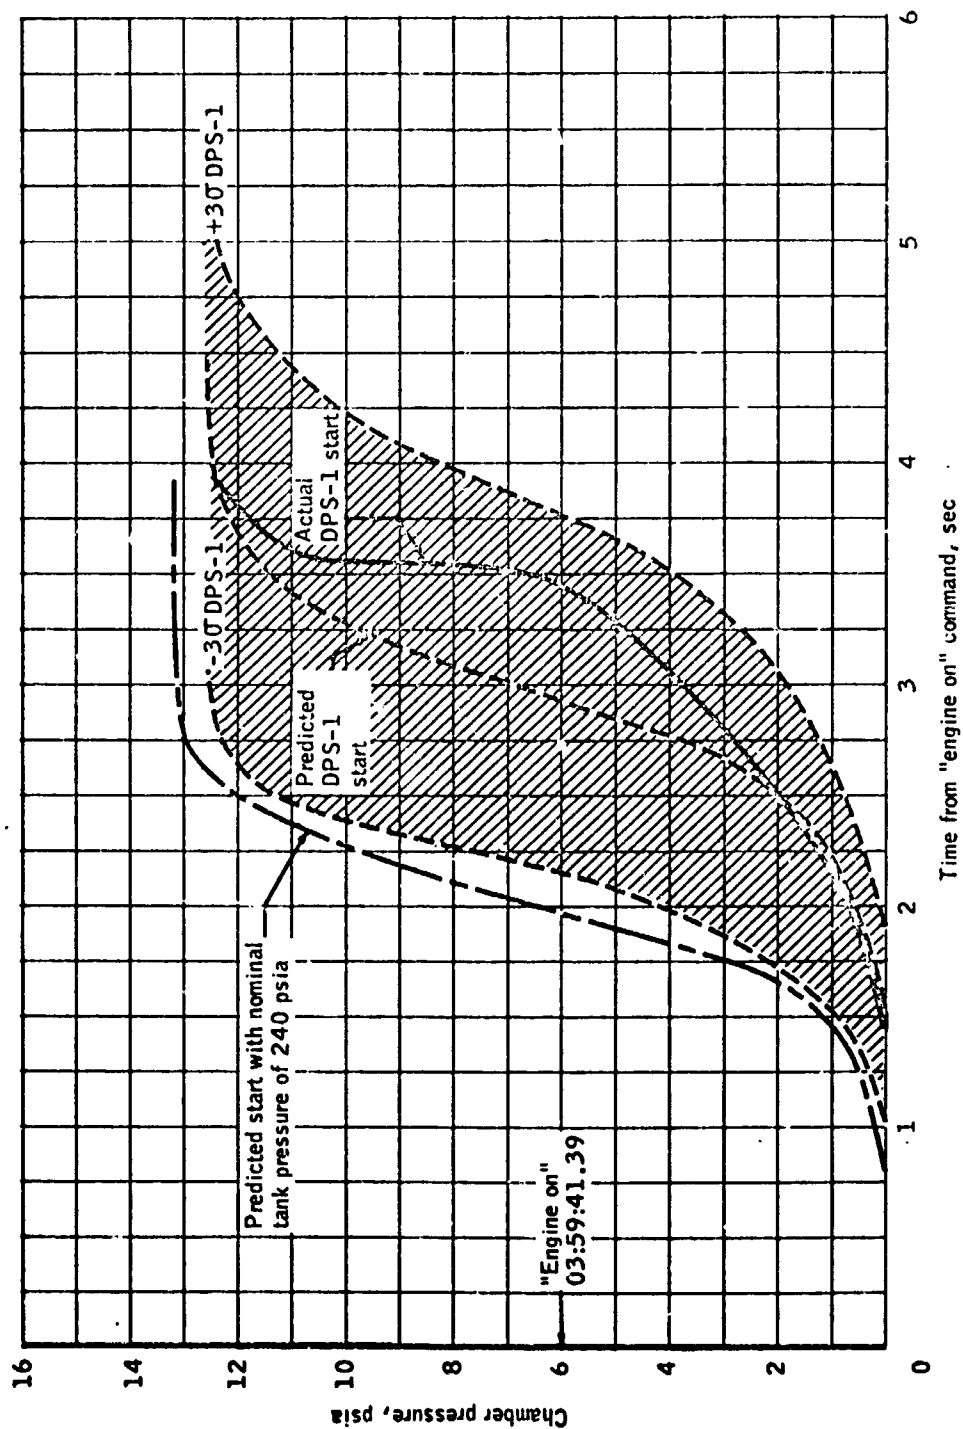
FIGURE 2.1-2 DPS-1 START TRANSIENTS

The effect of propellant tank pressures on the engine start characteristics is shown in Fig.2.1-2, including the predicted characteristics for nominal tank pressures of 240 psia. The descent engine first burn start characteristics associated with fuel and oxidizer tank pressures of 132 and 126 psia, respectively, were within the 3-sigma band computed from pre-flight test data.

The LM-1 descent engine thrust monitor program utilized thrust buildup data based on nominal start characteristics for tank pressures of 240 psia instead of the actual fuel and oxidizer tank pressures of 132 and 126 respectively. The slower than normal thrust buildup resulted in failure of the engine to meet the thrust/time criteria programmed in the LGC.

2. All LGC logic and electrical circuits that could issue any engine cutoff or inhibit any engine start will be evaluated to determine which should be eliminated or altered and which should be retained within the software. The LGC shutdown capability is not incorporated in the computer logic on manned missions.

3. Software and hardware compatibility will continuously be reviewed for each LM flight to insure proper systems integration.

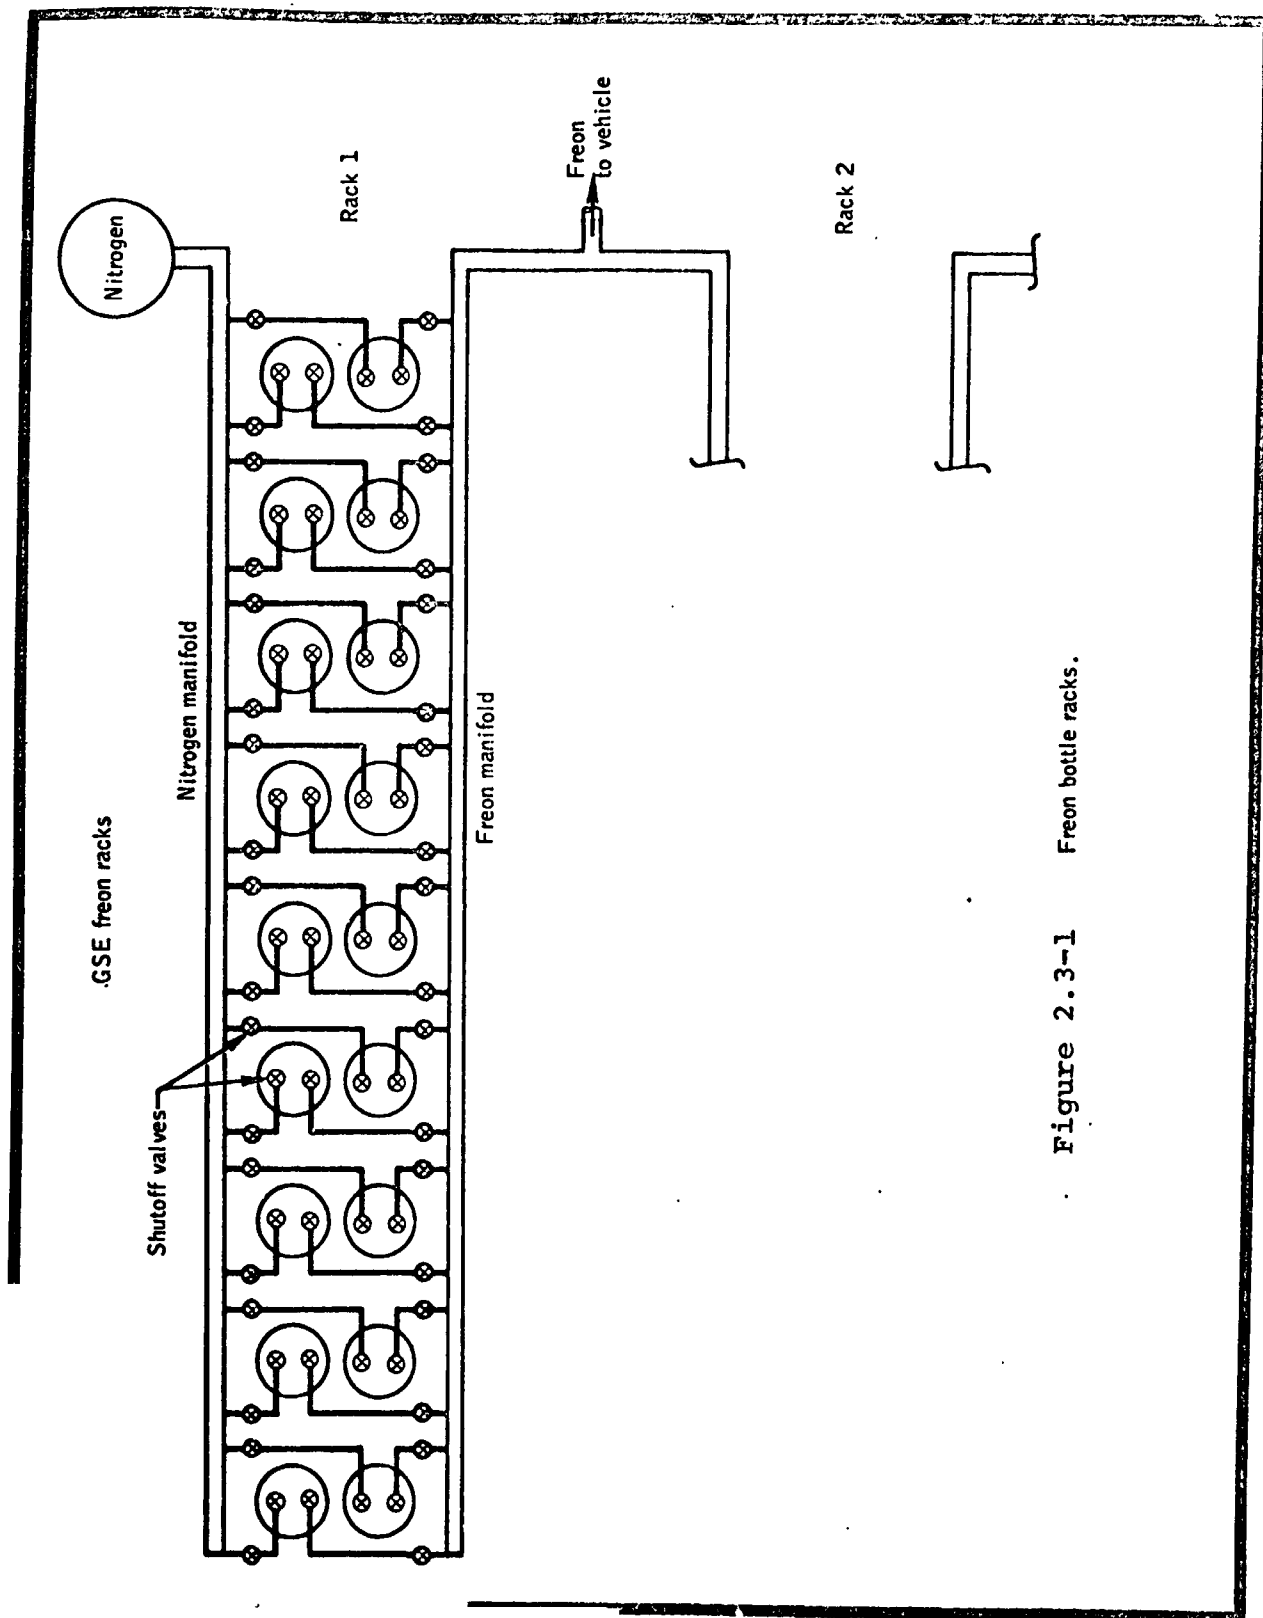
Figure 2.3-1 Freon bottle racks.

At T minus 3 hours freon delivery pressure to the LM dropped from 276 PSI to 146 PSI and the heat transport system coolant temperature began to increase from 50 to 64°, indicating loss of freon cooling. A hold was called at T minus 2.5 hours. The problem was isolated to rack 1 and rack 1 was shutdown. The count has resumed using rack 2. At this time rack 1 was showing a weight loss of 60 LB/HR, which was half of the total freon flow, although the rack was turned off. No action was taken.

At approximately T minus 50 minutes with rack 1 showing a weight loss equivalent to two bottles, the problem recurred; flow rate increased, delivery pressure decreased and LM coolant temperature increased. By lowering freon flow rates to between 40 and 80 LB/HR, LM coolant temperatures were maintained at 50+ 5° F. This temperature was maintained within the prescribed limits until launch.
